BYLAW NO. 559

A BYLAW TO AUTHORIZE THE DISPOSITION OF THE PORT NEVILLE WHARF FACILITY

January 20, 2022 | Revision A

Marine Facility Condition Assessment of the Port Neville Wharf

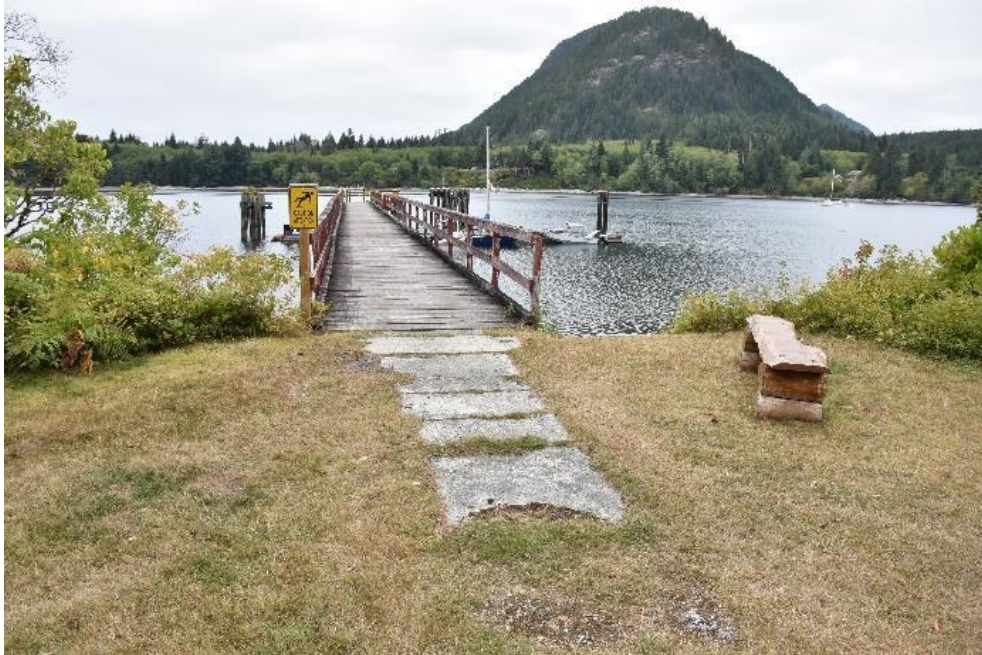
Photo 1 – Pier Approach Area

The pier approach is in generally good condition (Photos 1). There are no signs of settlement in this area, and the slope around the pier abutment appears stable. No load rating sign has been posted.

Repairs are not considered necessary at this time; however ongoing monitoring of the pier approach is recommended. Consideration should also be given to posting a load rating sign and extending safety barriers to the approach area.

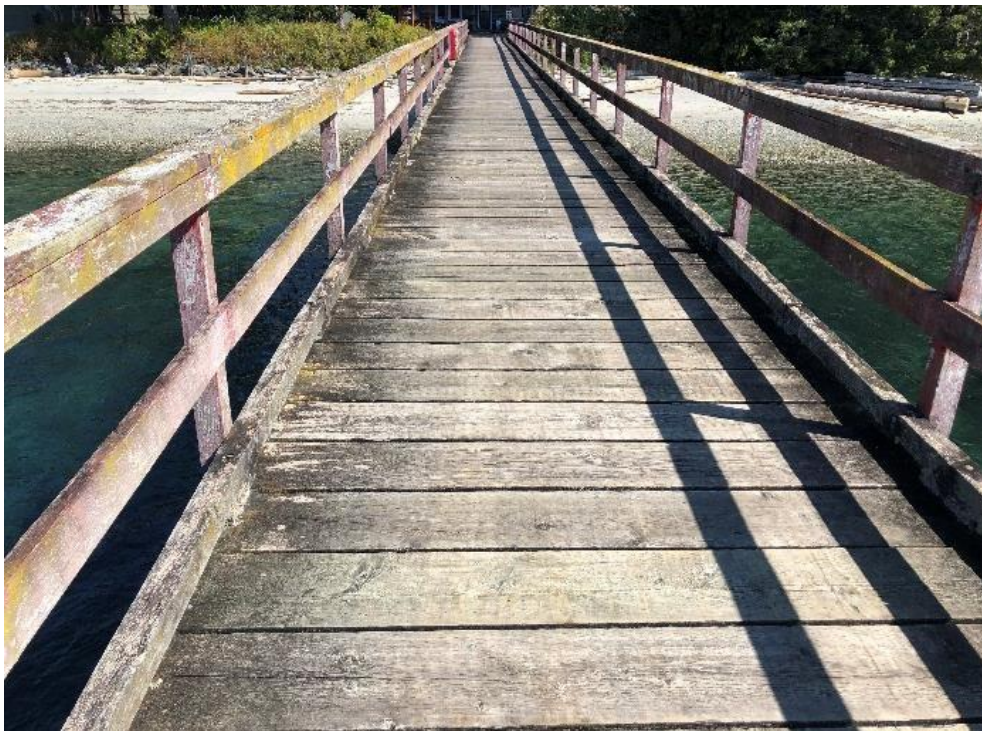
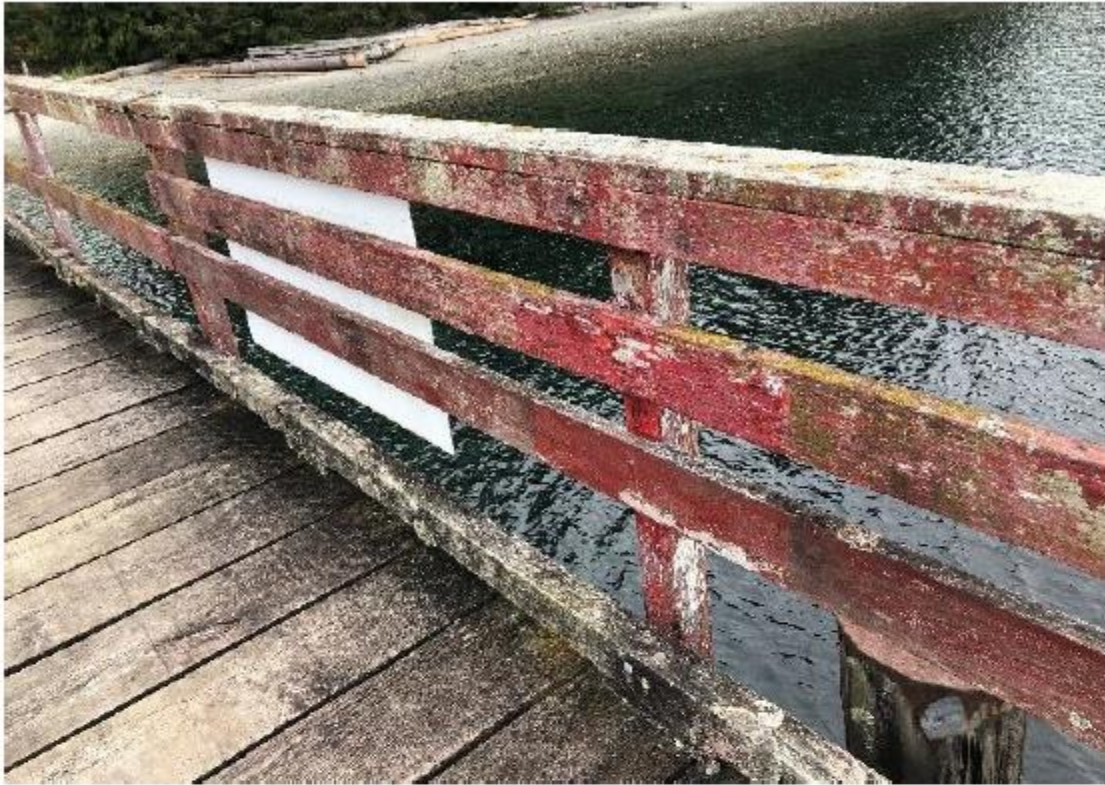
The pier topsides are generally in poor to fair condition with widespread weathering and fungal decay (Photos 2 & 3). Inspection findings are as follows:

Photo 2 – Pier Structure Topsides

Photo 3 – Pier Structure Handrails

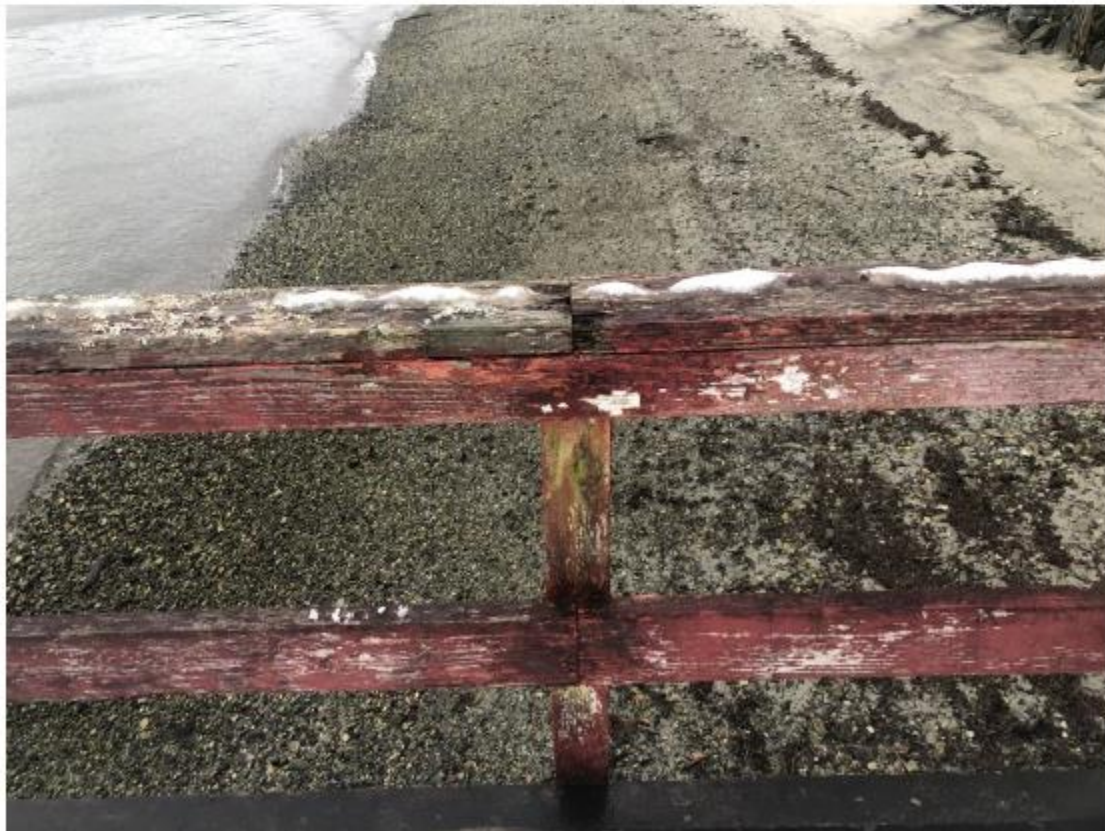
- The handrails appear generally well secured. The handrail posts are connected to the pier structure with two bolts, one through the outer stringer, and one through the bull rail. In some locations, the bull rails are deteriorated or not fully secured, and the handrail posts can shift, however they are still well secured to the stringer. There is significant deterioration to multiple other top rail connections, the approximate locations are directly above the following piles:

Photo 4 – Handrail deterioration between piles 4B and 5B

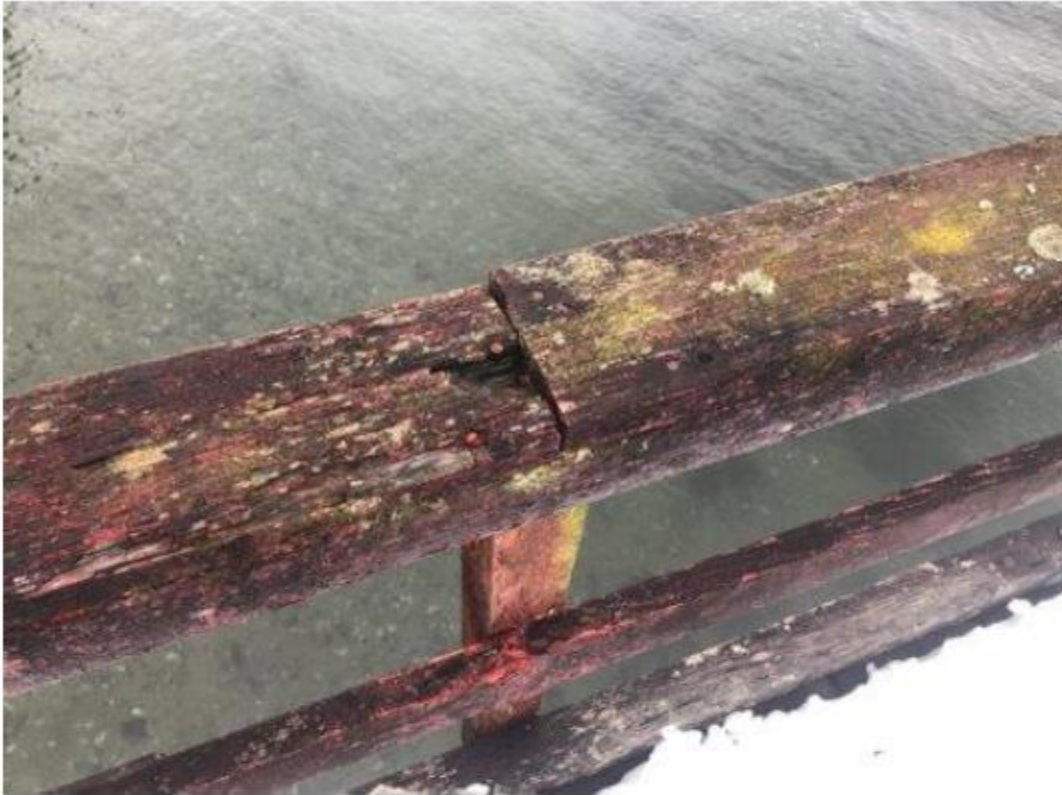
Photo 5 – Handrail deterioration between piles 7A and 8A

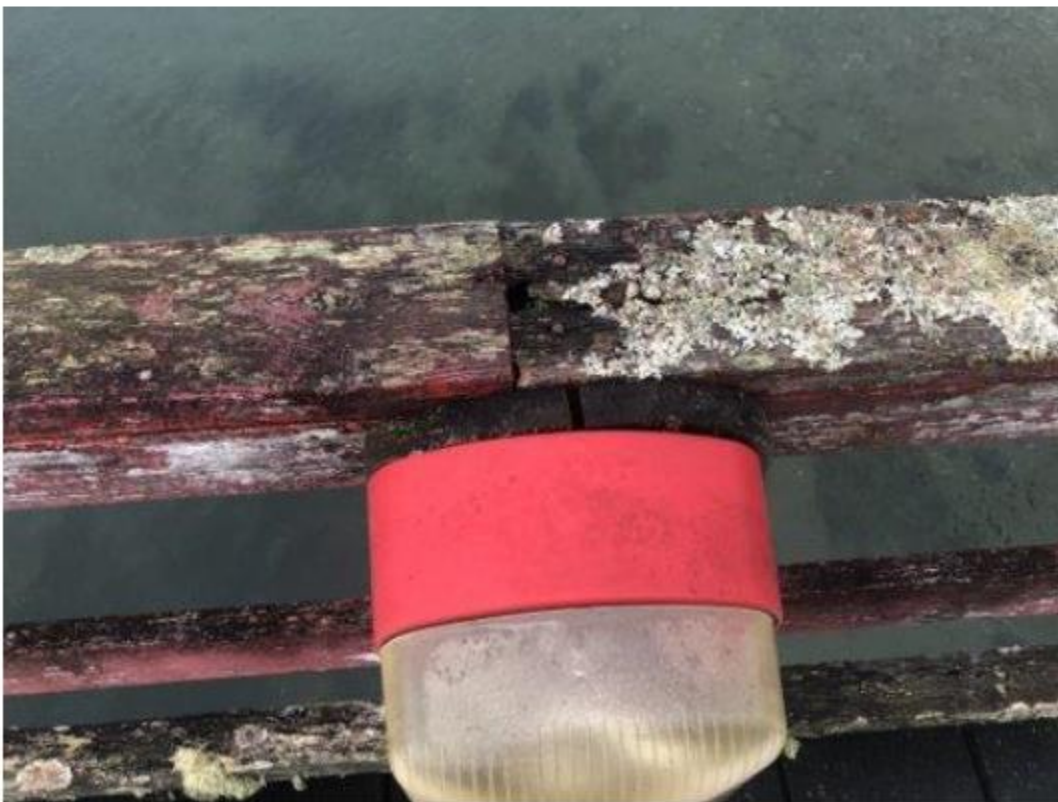
Photo 6 – Handrail deterioration between piles 8B and 9B

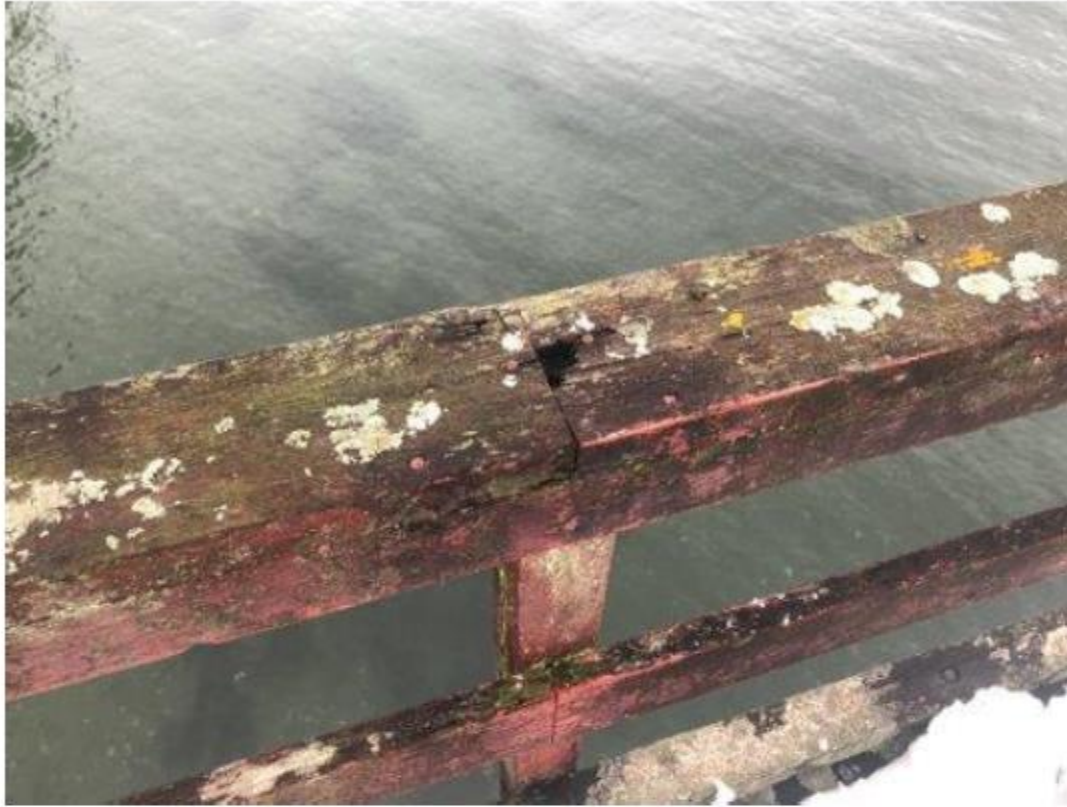
Photo 7 – Handrail deterioration between piles 9A and 10A

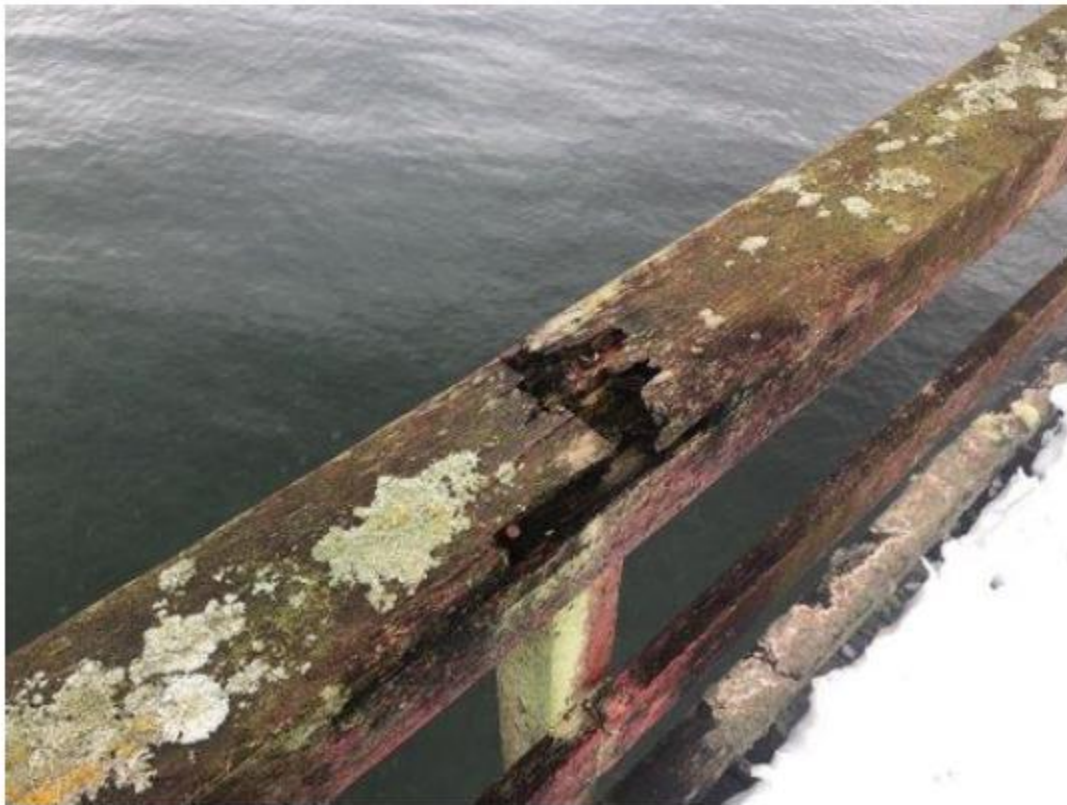
Photo 8 – Handrail deterioration between piles 11A and 12A

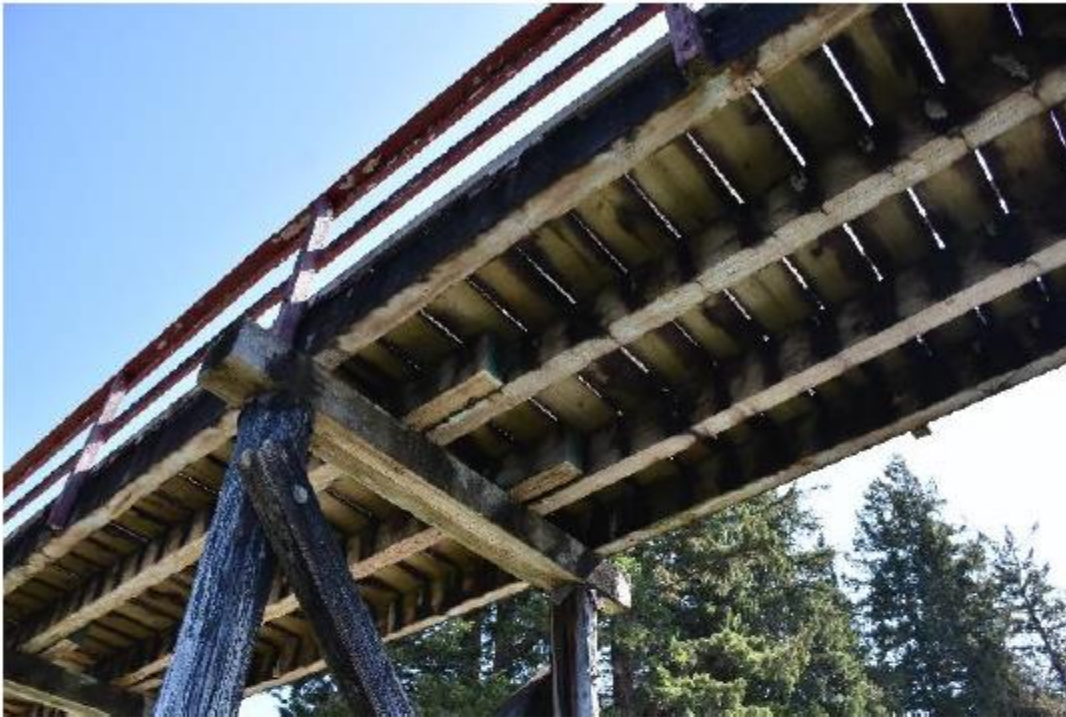
Photo 11 – Typical View of Timber Stringers

The treated timber stringers are generally in good condition (Photo 11). The stringers appear well secured between the decking and the pile caps, and there are no signs of significant splitting or structural deterioration. The ends of the stringers, where the end grain is present, does not show significant evidence of moisture or fungal decay. No cross-sectional loss was found in the stringers during the timber coring inspection.

Repairs are not considered necessary at this time; however ongoing monitoring of the stringers is recommended.

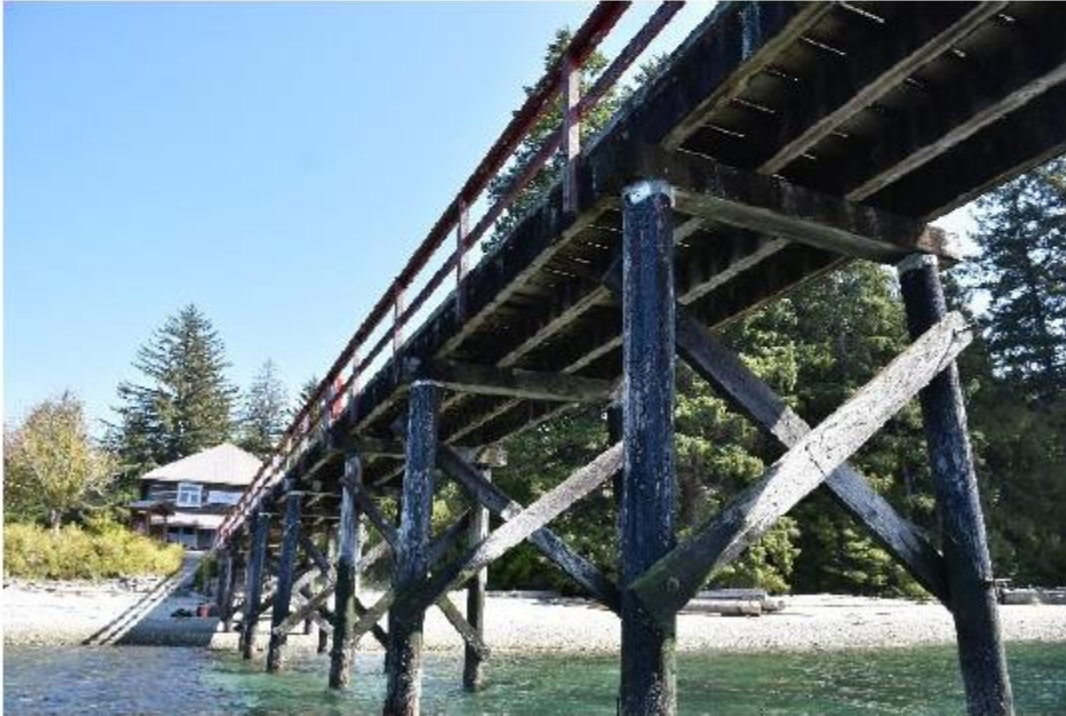
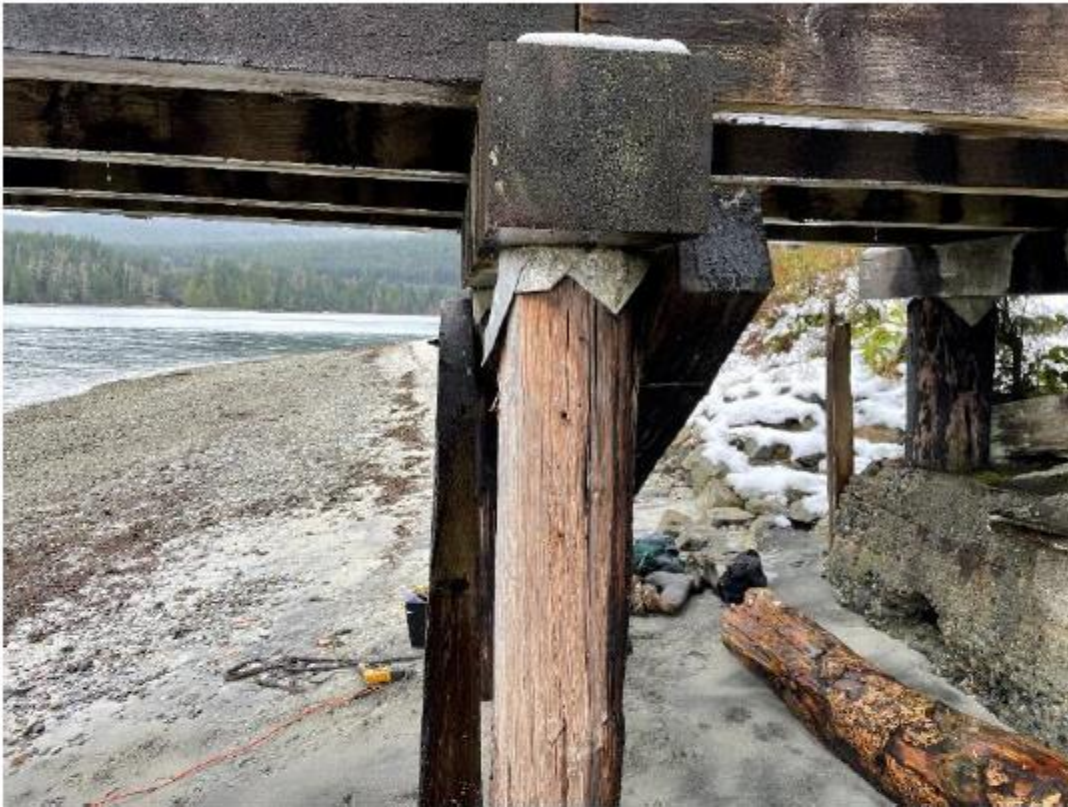
The treated timber pile caps are generally in fair to good condition (Photo 12 & 13). The pile caps appear well secured, and there are no signs of significant splitting or structural deterioration. The pile caps are typically aligned well over the piles, with no evidence of shifting or displacement. There is minor weathering and deterioration to the end grains of the pile caps, notably at Bent 12 (Photo 14). No cross-sectional loss was found in the pile caps during the timber coring inspection.

Photo 12 – General View of Timber Pile Cap Bents

Photo 13 – Typical Timber Pile Cap End Grain

Repairs are not considered necessary at this time, however ongoing monitoring of the pile caps and of the deterioration at the end grains is recommended.

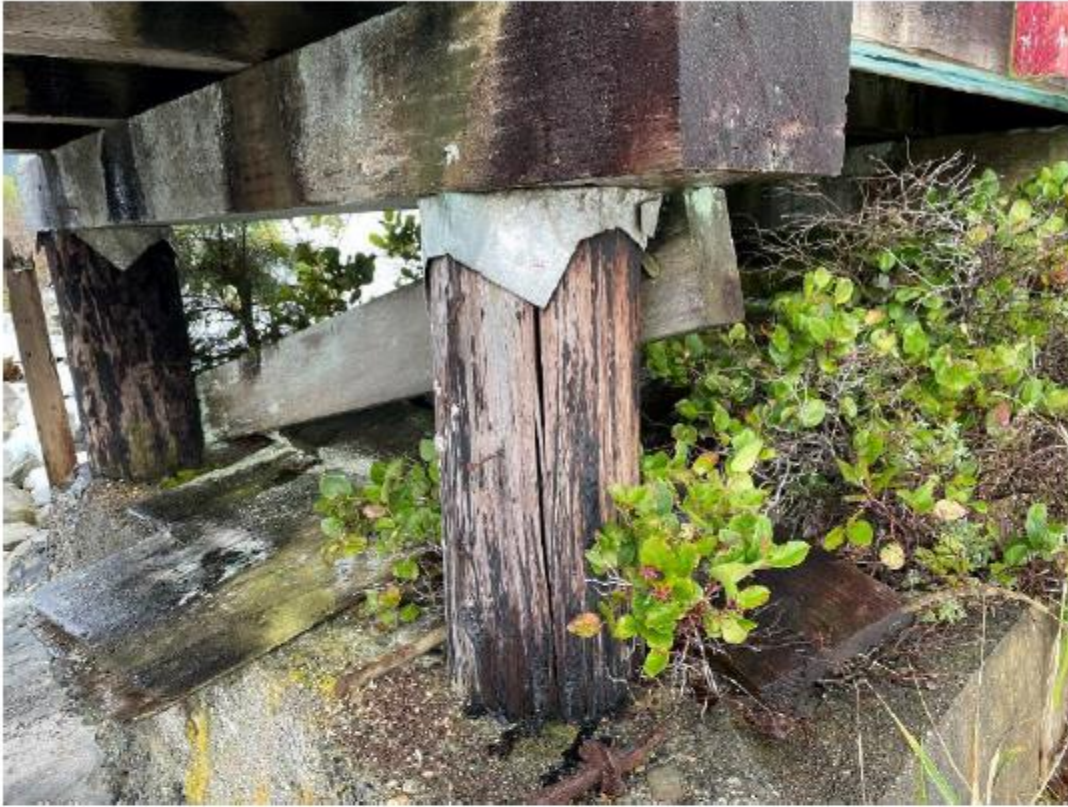
Location	Description	Recommendation
Pile 2A	Large split at the top of the pile. (Photo 15) 50% CSL due to internal fungal decay in the top 0.6m.	Replace timber pile.
Pile 2B	25% CSL due to internal fungal decay in the top 0.3m.	Monitor.
Pile 3A	25% CSL due to internal fungal decay in the top 0.3m.	Monitor.
Pile 3B	Moderate splitting at the top of the pile. (Photo 16) 25% to 75% CSL due to internal fungal decay in the top 0.9 m.	Replace timber pile.
Pile 4B	25% CSL due to internal fungal decay in the top 0.3m with wet fibres. Concrete footing is exposed, with signs of undermining and spalling of the concrete. (Photo 17)	Monitor.
Pile 5A	Moderate splitting at the base of the pile. (Photo 18)	Monitor.
Pile 5B	25-50% CSL due to internal fungal decay in the top 0.3m with wet fibres.	Replace timber pile.
Pile 7A	Pile is slightly misaligned. (Photo 19)	Monitor.

Photo 15 – Split in Pile 2A

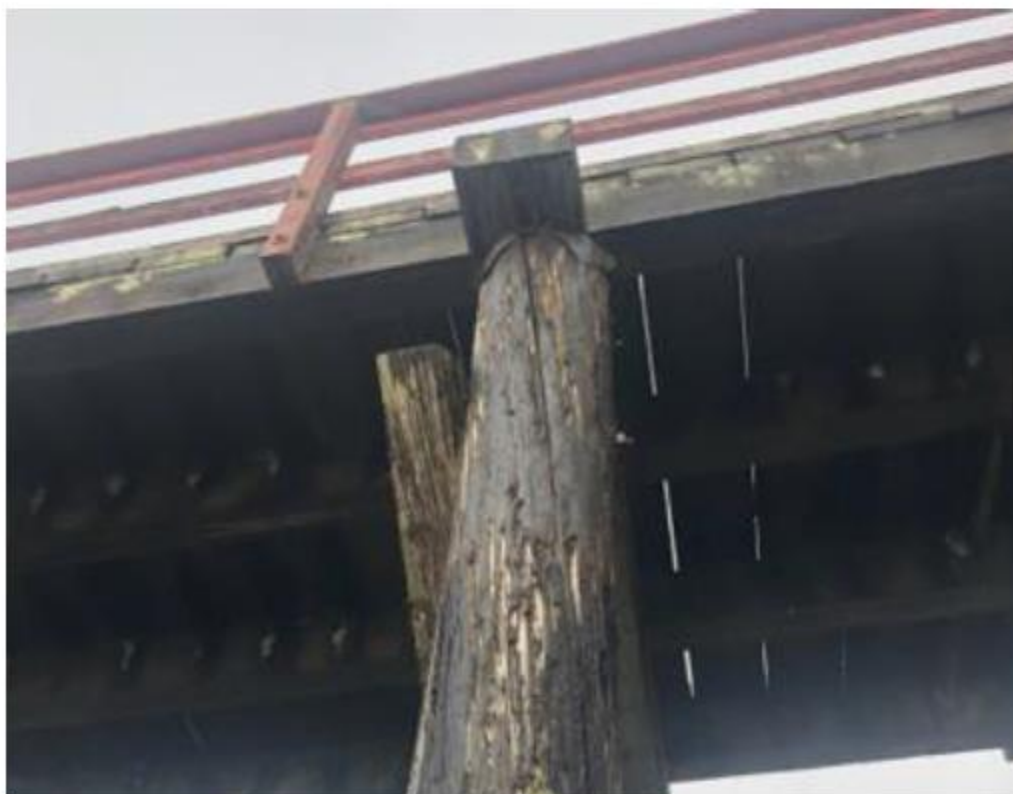
Pile 8A	Moderate splitting at the top of the pile. (Photo 20)	Monitor.
Pile 9A	Large open bolt hole at the top of the pile, likely from a previous cross-brace bolted connection. (Photo 21)	Monitor.
Pile 10A	Moderate splitting at the top of the pile. (Photo 22)	Monitor.
Pile 12A	Large open bolt hole at the top of the pile, likely from a previous cross-brace bolted connection. (Photo 23)	Monitor.
Pile 15B	Moss growing out of the top, indicating that there is fungal decay in the interior of the pile in this location. (Photo 24)	Monitor.

Photo 20 – Split in Pile 8A

Repairs are not considered necessary at this time; however ongoing monitoring of the piles and areas of damage is recommended. It is anticipated that the piles identified with splitting and open holes will have established internal fungal decay in the next 5-10 years and should be considered for replacement.

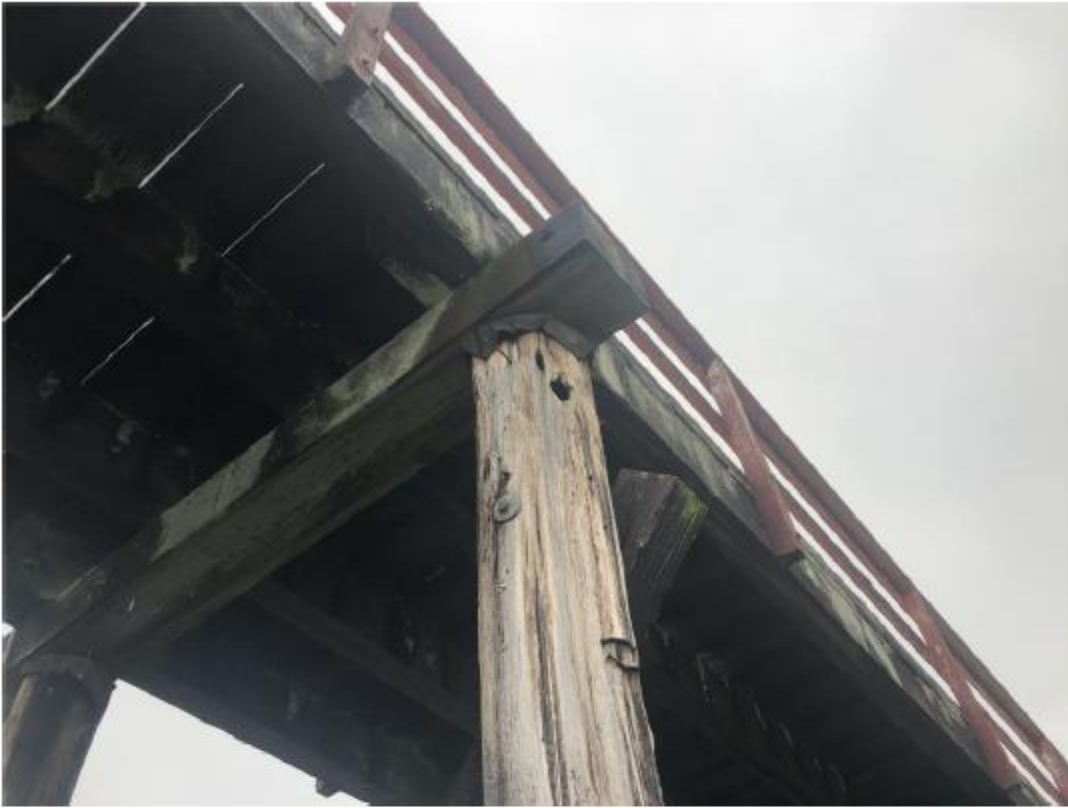
Photo 21 – Hole in Pile 9A

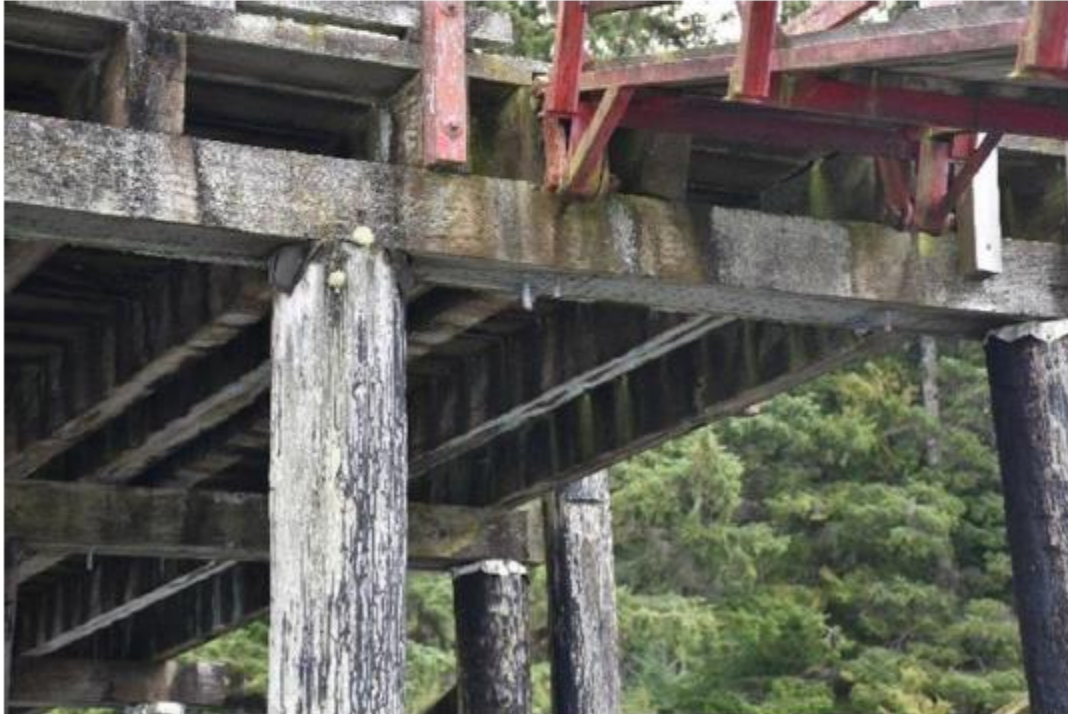
Photo 24 – Moss growth in Pile 15B

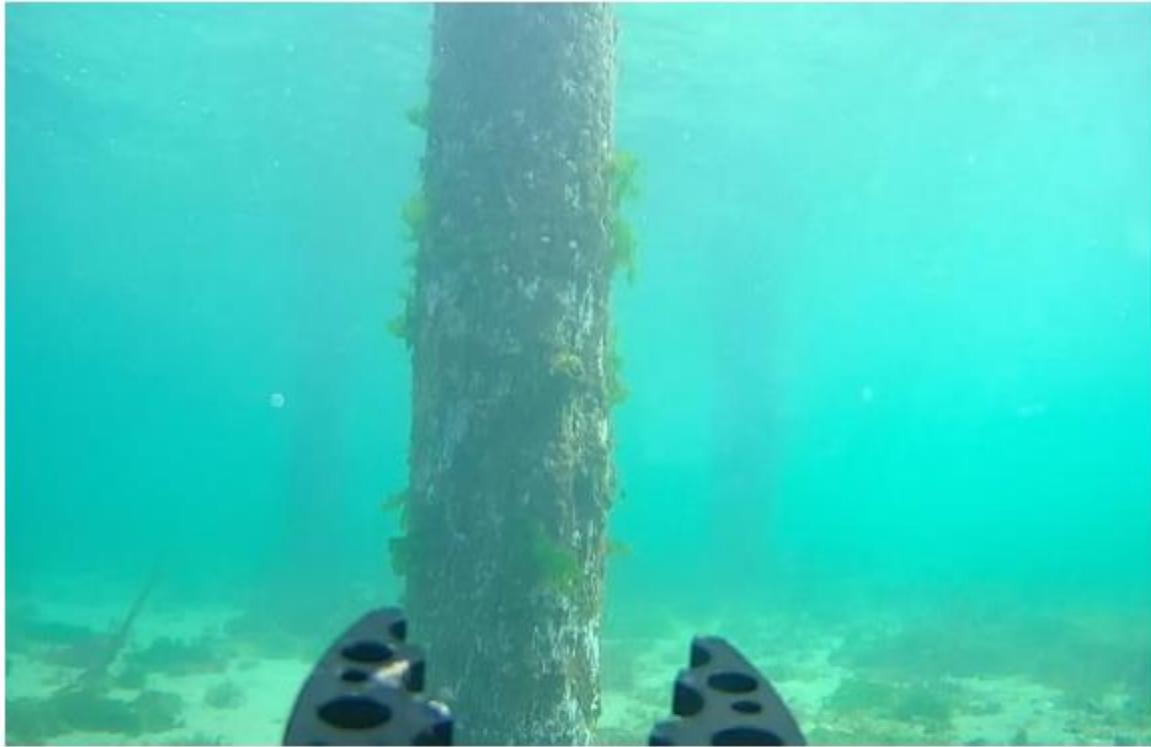
- Fender Pile 10B has a marine borer cavity in the lower intertidal zone with 25% cross-sectional loss (CSL) (Photo 25).
- Fender pile 14A has a large marine borer cavity with 50% CSL, and likely severe cross section loss due to fungal decay (Photos 26 & 27). Marine growth appears to be coming out of the pile.
- Fender pile 15C has a large marine borer cavity with 50% CSL, and likely severe cross section loss due to fungal decay (Photo 28).

Photo 25 – Underwater image of damage to fender Pile 10B

McElhanney understands that the fender piles are not longer used for vessel moorage and repairs are not considered necessary at this time as the fender piles are not structurally important to the pier.

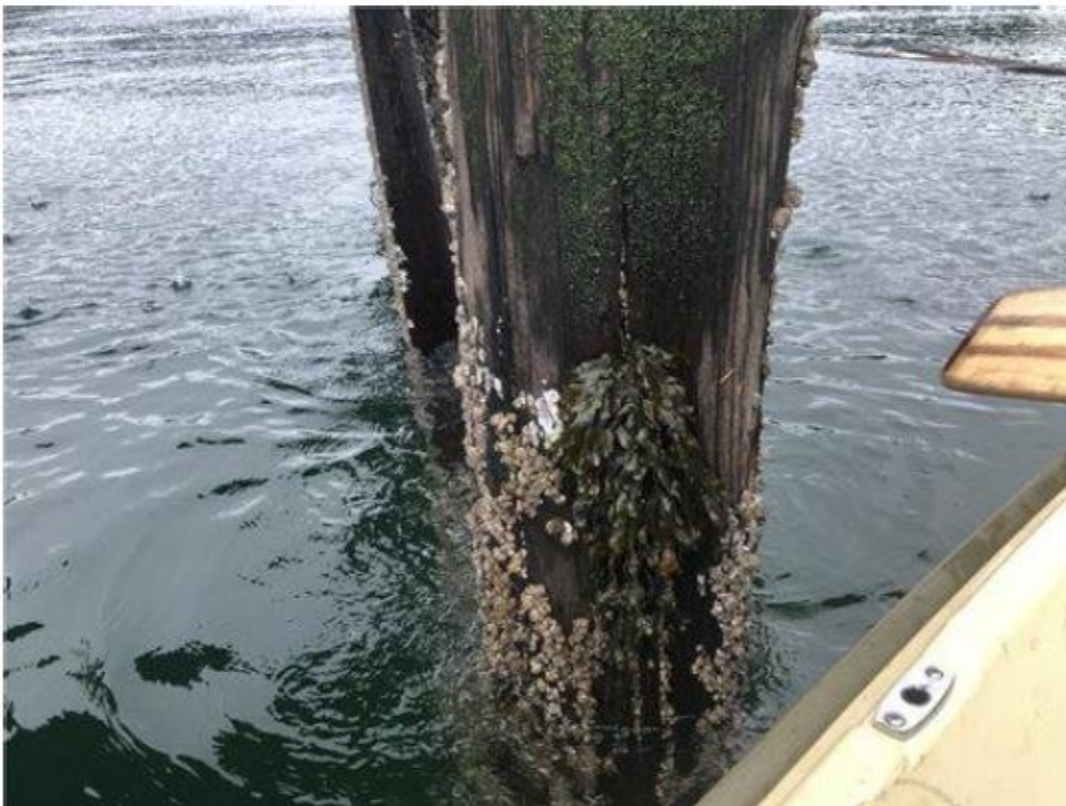
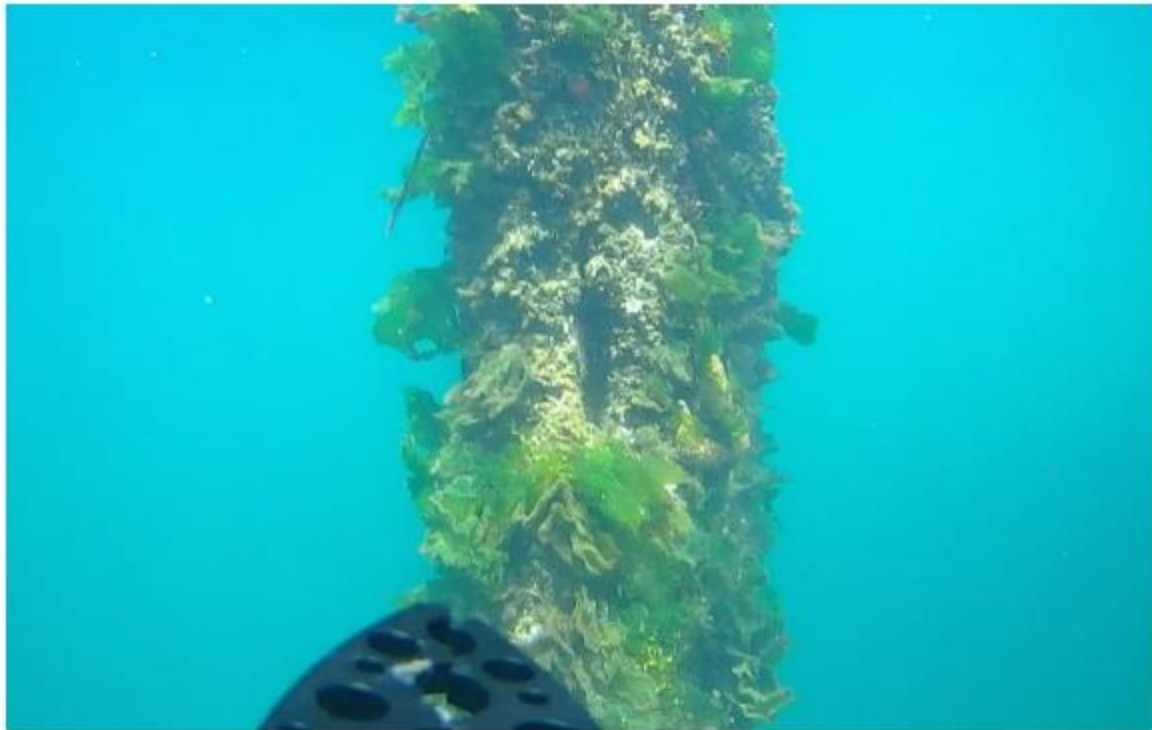
Photo 26 – Fender Pile 14A

Photo 27 – Underwater image of marine borer cavity of fender pile 14A

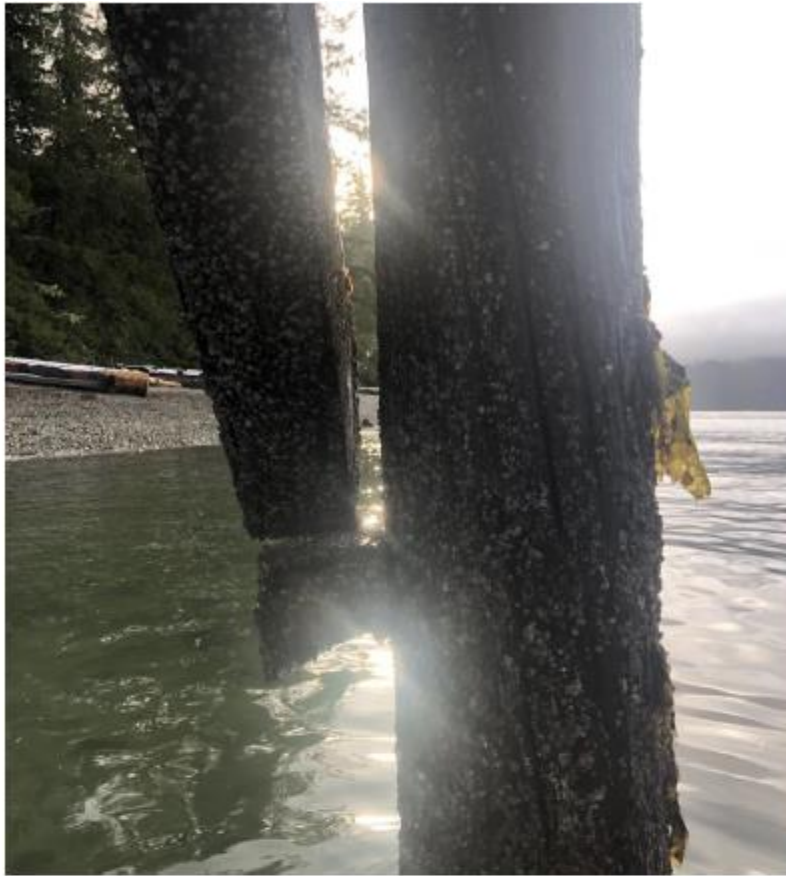
Photo 29 – Cross Bracing at Bent 8

- There is widespread weathering, and minor fungal decay to the end grains of the members, however all cross braces appear well secured to the piles, apart from two locations.
- The cross bracing at Bent 8 appears to not be connected to pile 8A and is only resting on a timber block secured to the pile. (Photo 29)
- The cross bracing at Bent 15 is connected to the fender pile 15C, which has signs of significant cross-section loss. (Photo 30)

It is recommended that the cross braces at Bents 8 and 15 are re-secured. Ongoing monitoring of the cross bracing is recommended.

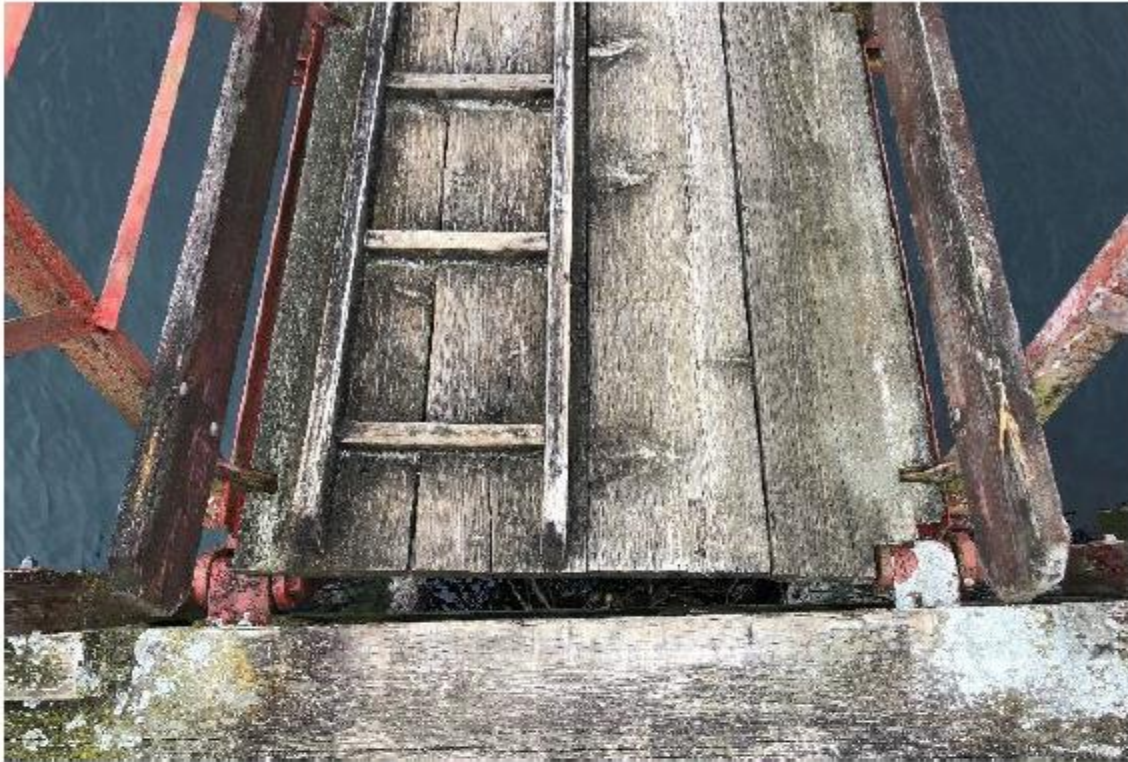
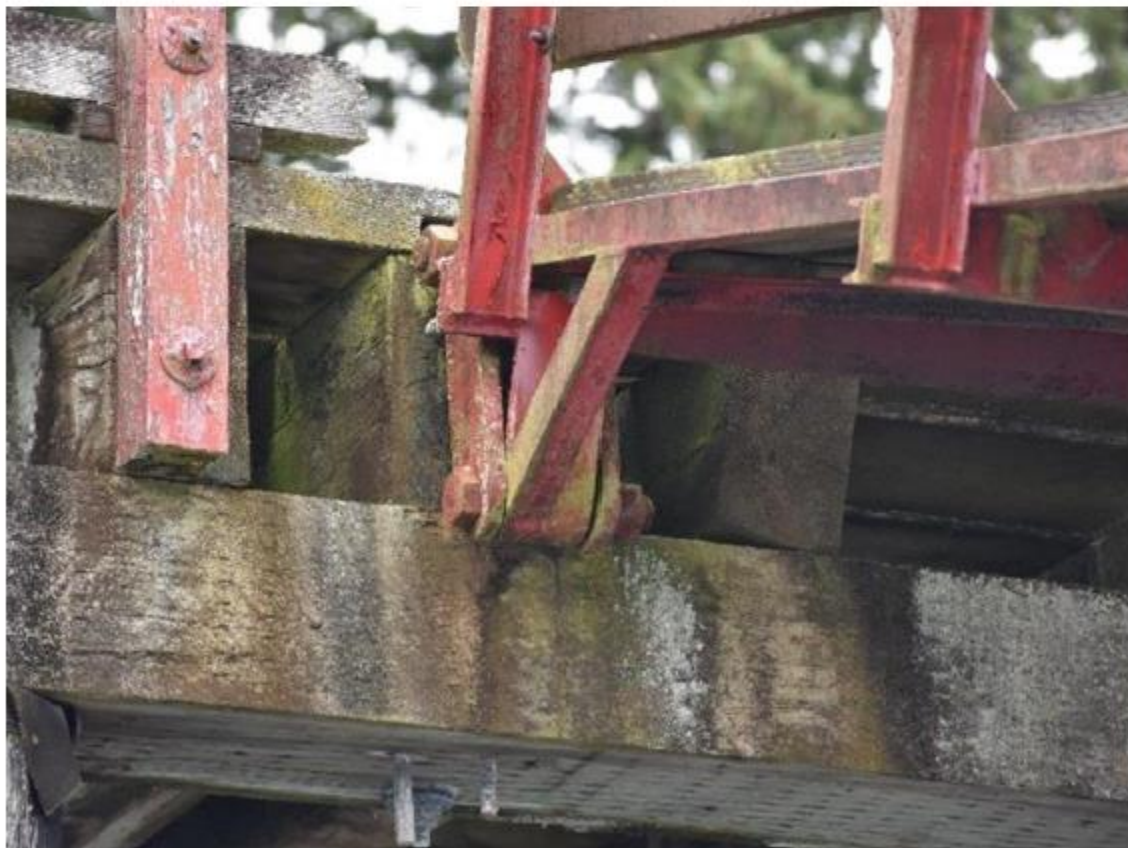
- The upper hinge connection is slightly misaligned (Photos 31 and 32) which is likely to result in advanced wearing of the pinned connection.
- The timber gangway slider plate is in good condition with minor wearing and is well aligned with the gangway roller (Photo 33)
- The deck planks and anti-slip surface have moderate wearing (Photo 34).
- The steel truss members have typical minor to moderate coating failures and corrosion. No significant deterioration of the welded connections was noted (Photo 35).

McElhanney recommends that the access gangway be replaced in conjunction with future replacement of the floating docks.

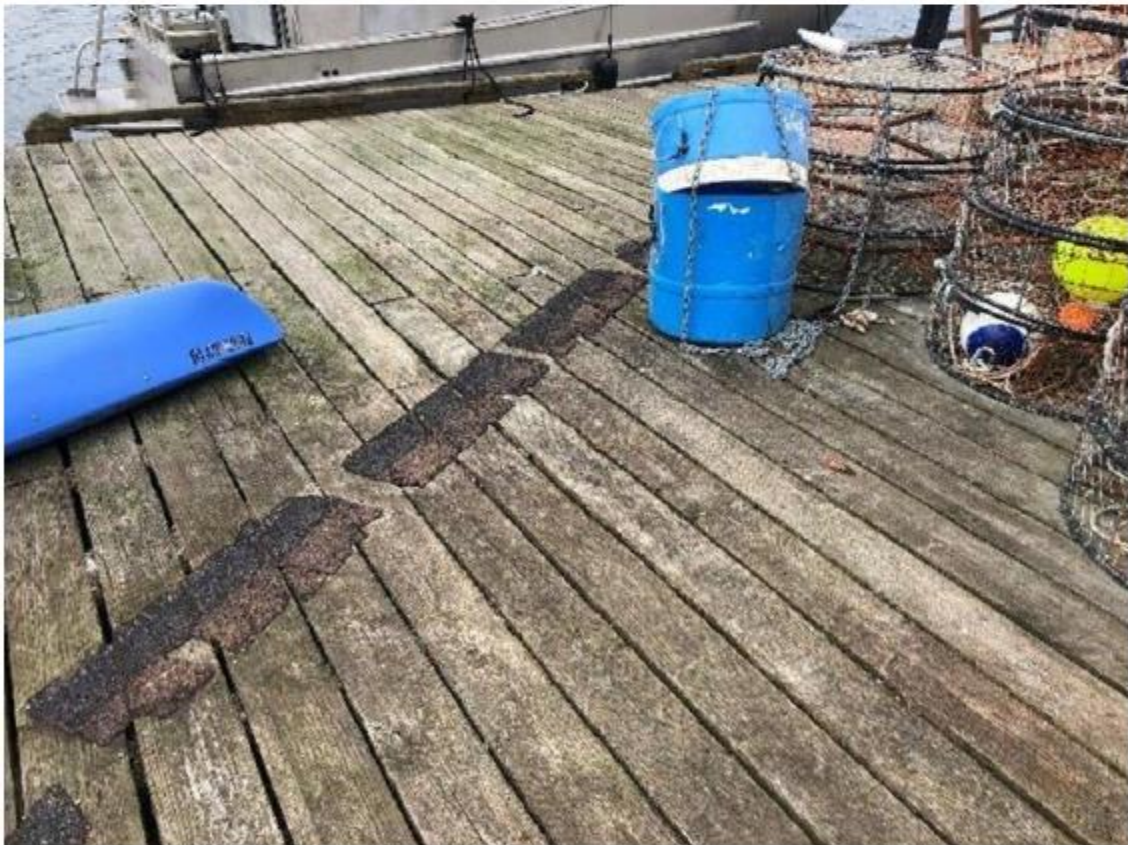
Photo 36 – General view of Float A

Float A is in poor to fair condition with minor deterioration to the topsides (Photo 36). Inspection findings are as follows:

Consideration should be given to replacing Floats A and B along with the mooring system rather than continue regular minor maintenance/repairs.

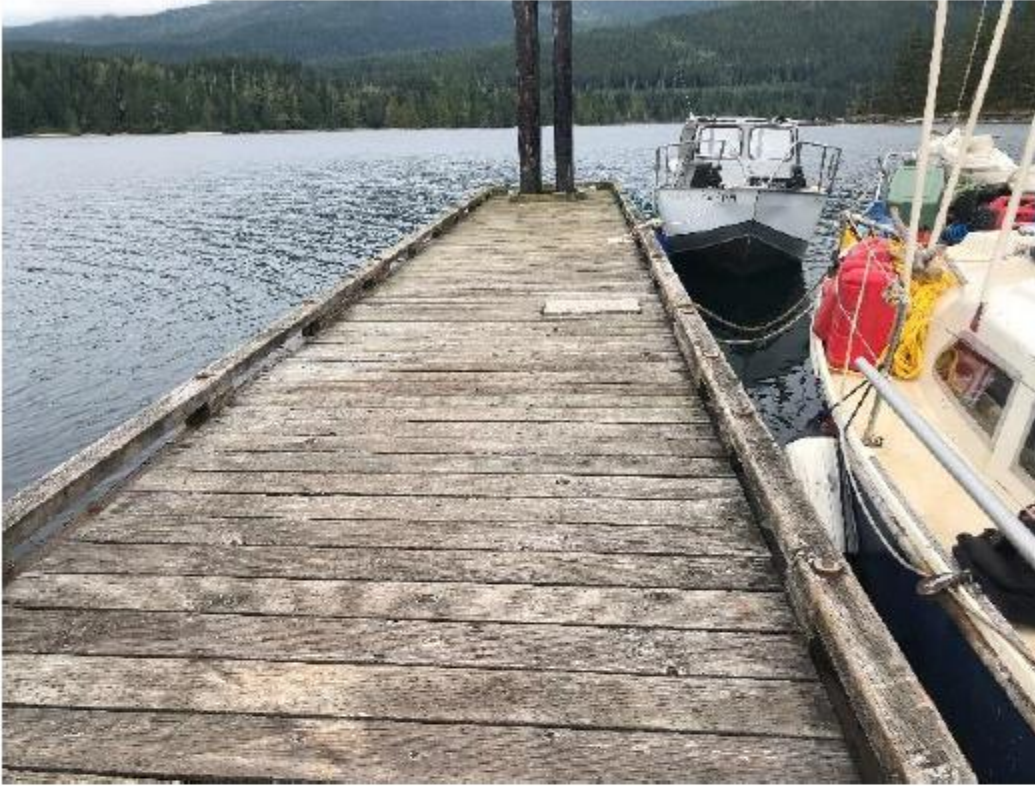
Photo 37 – General view of Float B

- The timber deck planks have widespread moderate weathering and fungal decay, with localized deterioration. There is one location on Float B with plywood repair to the decking which is a tripping hazard (Photo 37)
- The floatation elements appear in fair condition.
- The west connection between Float A and Float B is rope (Photo 38). This is currently functioning properly, however this may be subject to rapid wearing and should be replaced with a steel chain in the future.
- The bull rails and fascia boards have widespread mechanical damage (Photo 39). The bull rail is missing in two locations.
- The east connection between Float A and Float B is chain which is causing moderate wearing to the floats (Photo 40).
- The mooring piles and mooring dolphins have moderate abrasion with the dock structures (Photo 41 to 33).

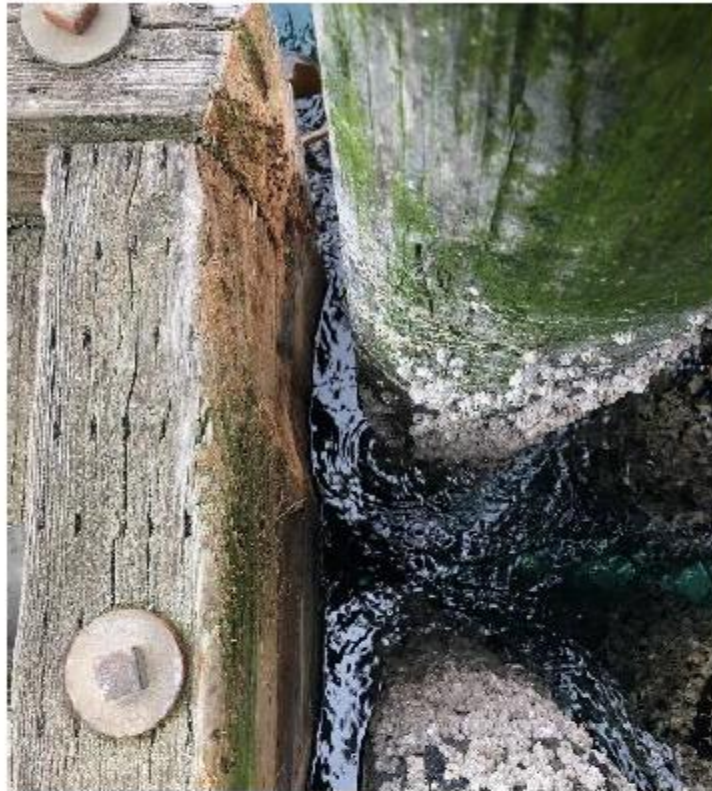
Photo 41 – Wearing to Float A from North Mooring Dolphin

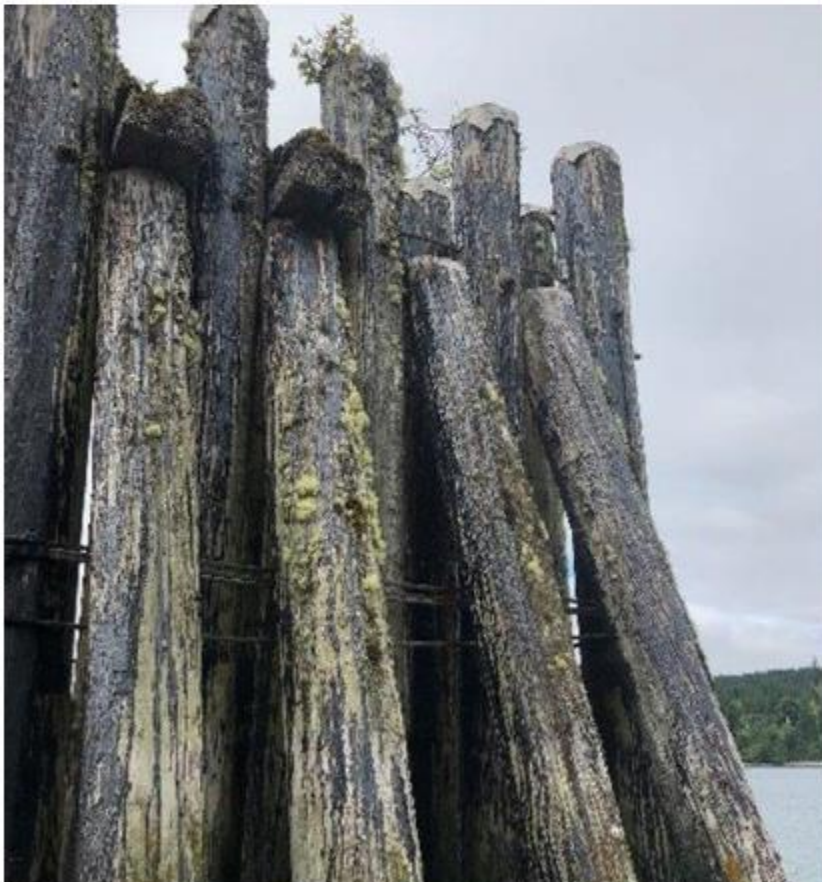
- The north dolphin has vegetation growth near the tops of some of the piles. The timber blocking near the tops of the piles is deteriorating, and the cable wraps are loose (Photo 44)
- The south dolphin has significant vegetation growth near the tops of the piles. There is also severe cross section loss due to internal fungal decay and marine borer cavity in the intertidal zone, specifically on the front facing piles. The timber blocking is in poor condition, and the cable wraps are loose, but remain in place (Photo 45).

Photo 44 – North Mooring Dolphin

McElhanney understands that the mooring dolphins are no longer in service. To mitigate the risk of timber members contacting the dock, it is recommended that the timber dolphins be entirely removed and disposed of.
