BYLAW NO. 559

A BYLAW TO AUTHORIZE THE DISPOSITION OF THE PORT NEVILLE WHARF FACILITY

January 20, 2022 | Revision A

Marine Facility Condition Assessment of the Port Neville Wharf

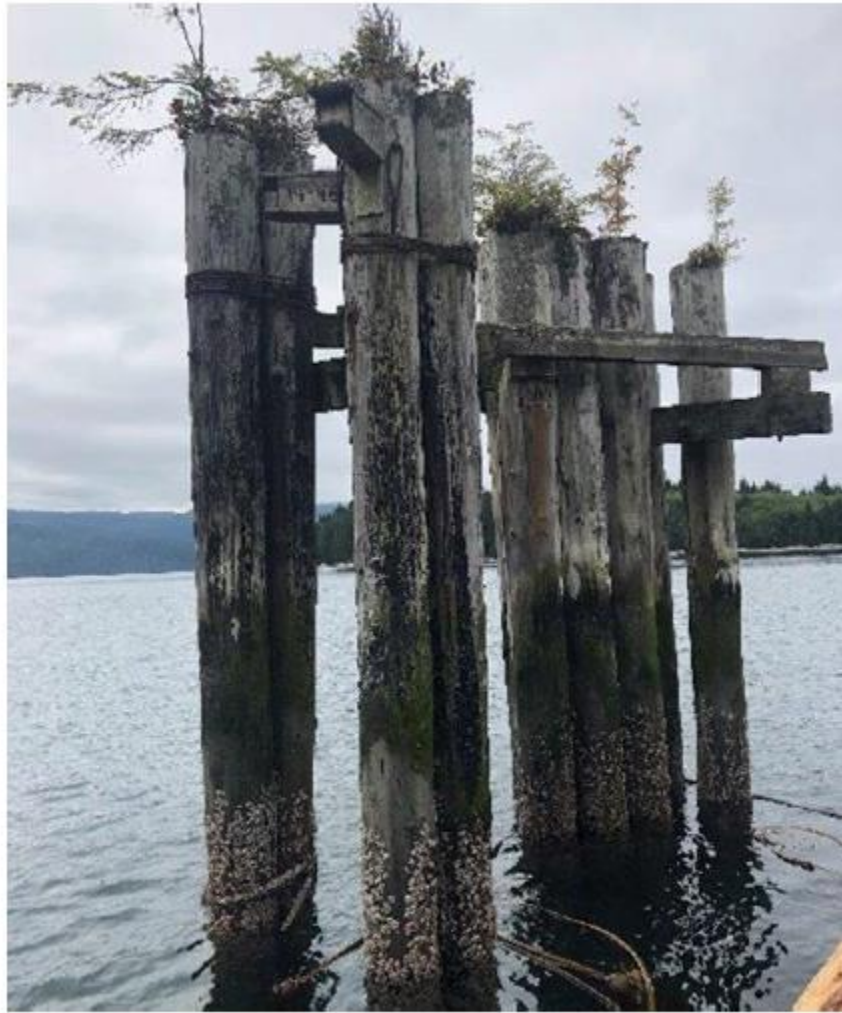
- The north dolphin has vegetation growth near the tops of some of the piles. The timber blocking near the tops of the piles is deteriorating, and the cable wraps are loose (Photo 44)
- The south dolphin has significant vegetation growth near the tops of the piles. There is also severe cross section loss due to internal fungal decay and marine borer cavity in the intertidal zone, specifically on the front facing piles. The timber blocking is in poor condition, and the cable wraps are loose, but remain in place (Photo 45).

Photo 45 – South Mooring Dolphin

McElhanney understands that the mooring dolphins are no longer in service. To mitigate the risk of timber members contacting the dock, it is recommended that the timber dolphins be entirely removed and disposed of.
