BYLAW NO. 559

A BYLAW TO AUTHORIZE THE DISPOSITION OF THE PORT NEVILLE WHARF FACILITY

January 20, 2022 | Revision A

Marine Facility Condition Assessment of the Port Neville Wharf

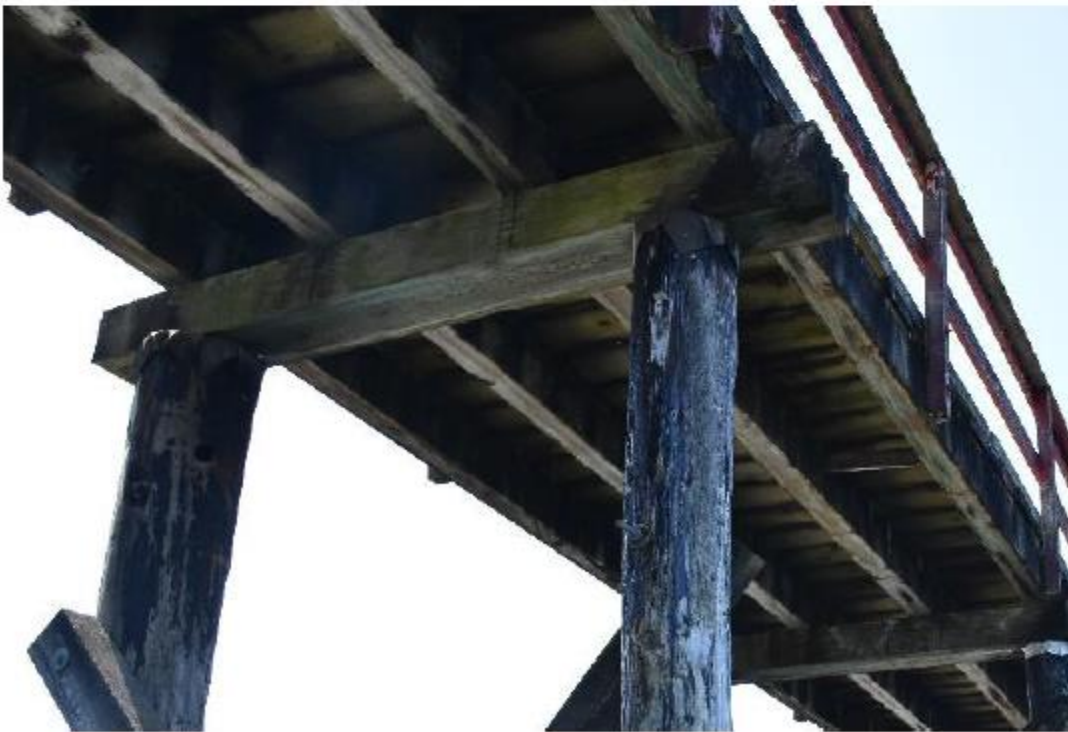
Photo 14 – Timber Pile Cap at Bent 12

The treated timber pile caps are generally in fair to good condition (Photo 12 & 13). The pile caps appear well secured, and there are no signs of significant splitting or structural deterioration. The pile caps are typically aligned well over the piles, with no evidence of shifting or displacement. There is minor weathering and deterioration to the end grains of the pile caps, notably at Bent 12 (Photo 14). No cross-sectional loss was found in the pile caps during the timber coring inspection.

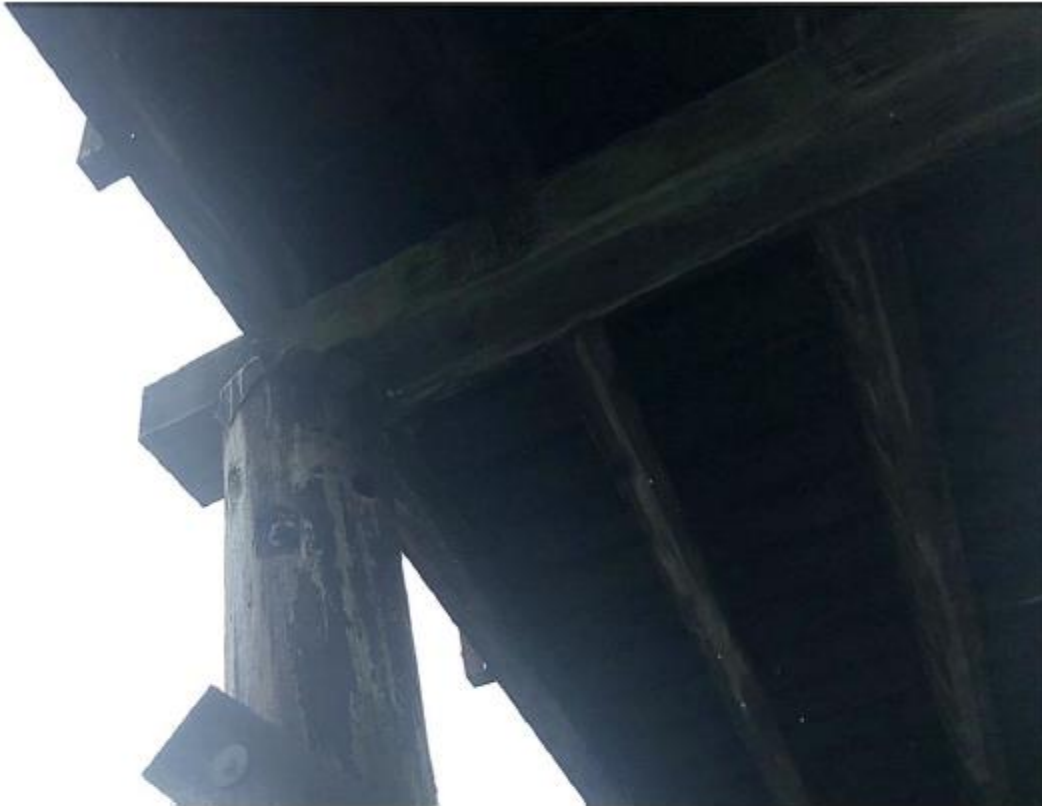
Photo 23 – Hole in Pile 12A

Pile 8A	Moderate splitting at the top of the pile. (Photo 20)	Monitor.
Pile 9A	Large open bolt hole at the top of the pile, likely from a previous cross-brace bolted connection. (Photo 21)	Monitor.
Pile 10A	Moderate splitting at the top of the pile. (Photo 22)	Monitor.
Pile 12A	Large open bolt hole at the top of the pile, likely from a previous cross-brace bolted connection. (Photo 23)	Monitor.
Pile 15B	Moss growing out of the top, indicating that there is fungal decay in the interior of the pile in this location. (Photo 24)	Monitor.

PILE REPAIRS	
FILE NO.	REPAIRS
1A	REPLACE PILE
2B	FRESH HEAD AND INSTALL NEW SINGLE CORNER
3A	FRESH HEAD AND INSTALL NEW SINGLE CORNER
3B	REPLACE PILE
4B	FRESH HEAD AND INSTALL NEW SINGLE CORNER
5A	REPLACE PILE
6A	INSTALL GALVANIZED STEEL PILE CLAMPS
6B	REPLACE PILE
10A	INSTALL GALVANIZED STEEL PILE CLAMPS
12A	REPLACE PILE
13-15	MODIFICATIONS TO TRUSSES SEE PLAN

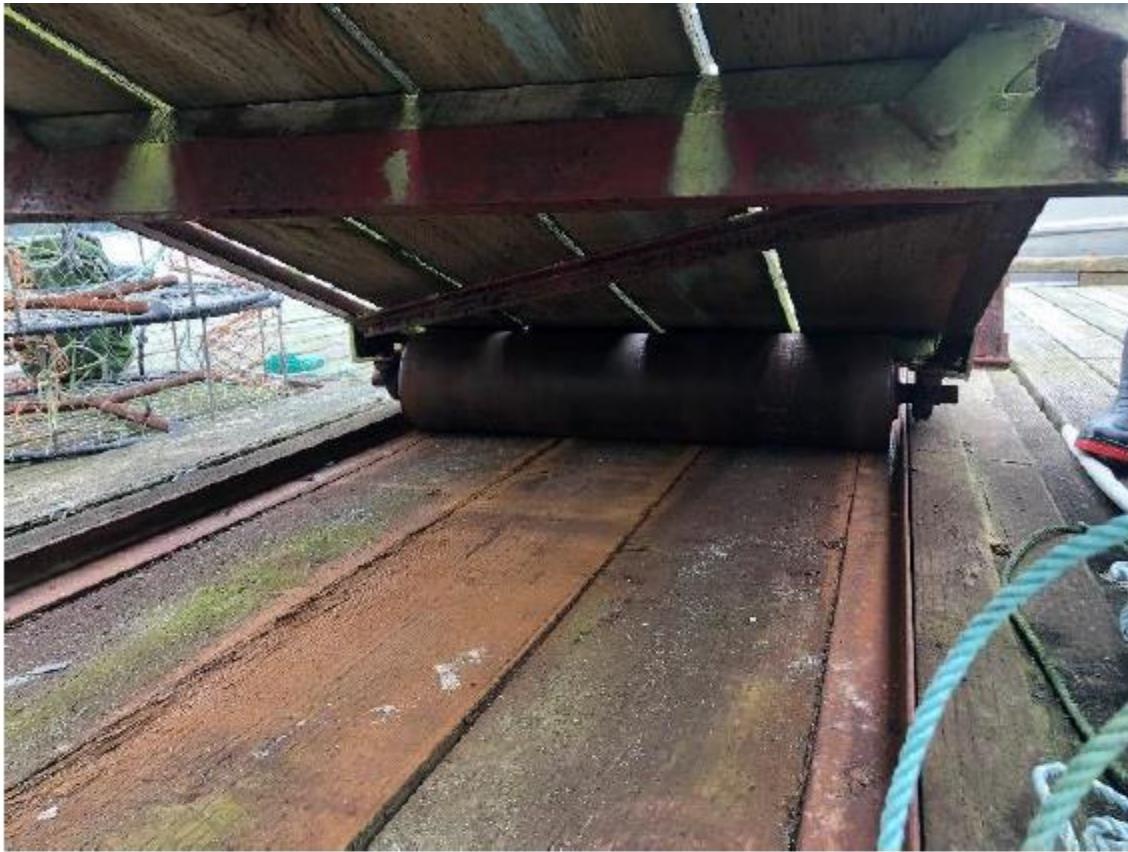
Photo 33 – Gangway Timber Slider Plate and Roller

- The upper hinge connection is slightly misaligned (Photos 31 and 32) which is likely to result in advanced wearing of the pinned connection.
- The timber gangway slider plate is in good condition with minor wearing and is well aligned with the gangway roller (Photo 33)
- The deck planks and anti-slip surface have moderate wearing (Photo 34).
- The steel truss members have typical minor to moderate coating failures and corrosion. No significant deterioration of the welded connections was noted (Photo 35).

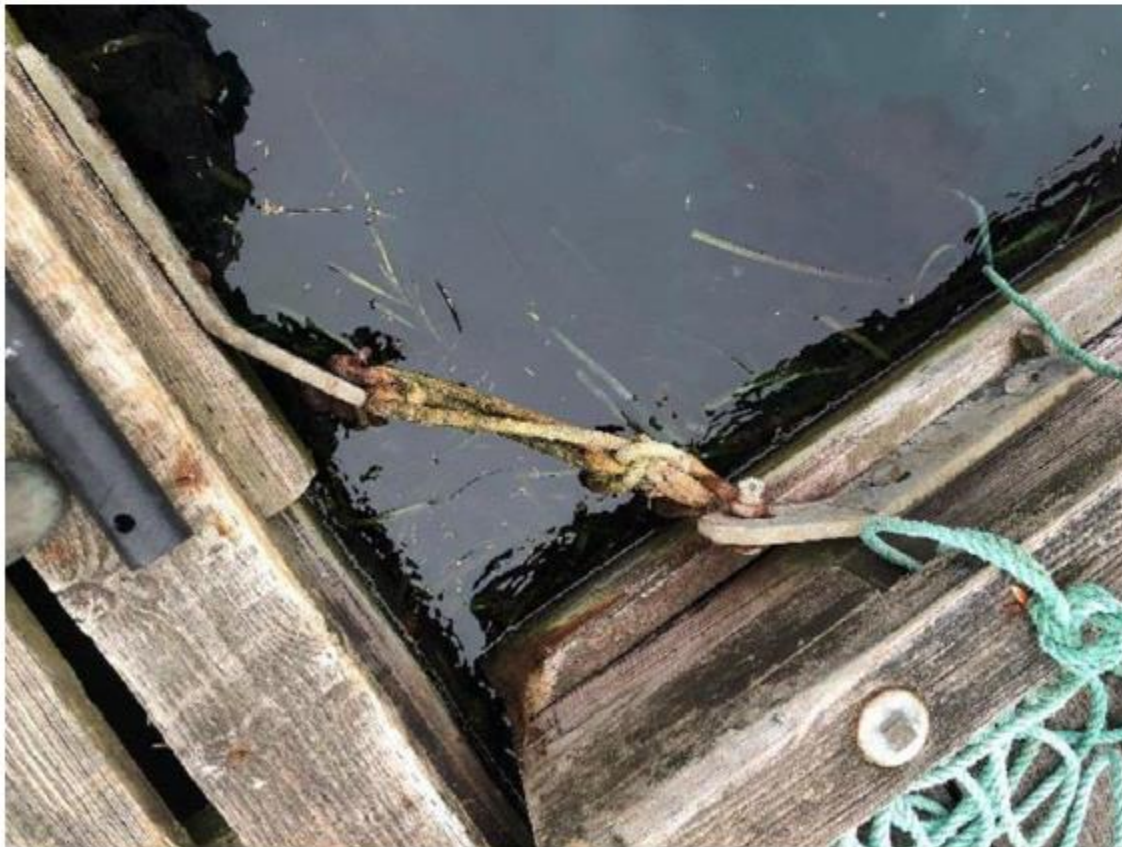
Photo 38 – Rope connection to Float B

- The timber deck planks have widespread moderate weathering and fungal decay, with localized deterioration. There is one location on Float B with plywood repair to the decking which is a tripping hazard (Photo 37)
- The floatation elements appear in fair condition.
- The west connection between Float A and Float B is rope (Photo 38). This is currently functioning properly, however this may be subject to rapid wearing and should be replaced with a steel chain in the future.
- The bull rails and fascia boards have widespread mechanical damage (Photo 39). The bull rail is missing in two locations.
- The east connection between Float A and Float B is chain which is causing moderate wearing to the floats (Photo 40).
- The mooring piles and mooring dolphins have moderate abrasion with the dock structures (Photo 41 to 33).
